Traffic Simulation Tests with Road Reflectors

Conference paper STRC 2005

5th Swiss Transport Research Conference
Monte Verità / Ascona, March 9-11, 2005

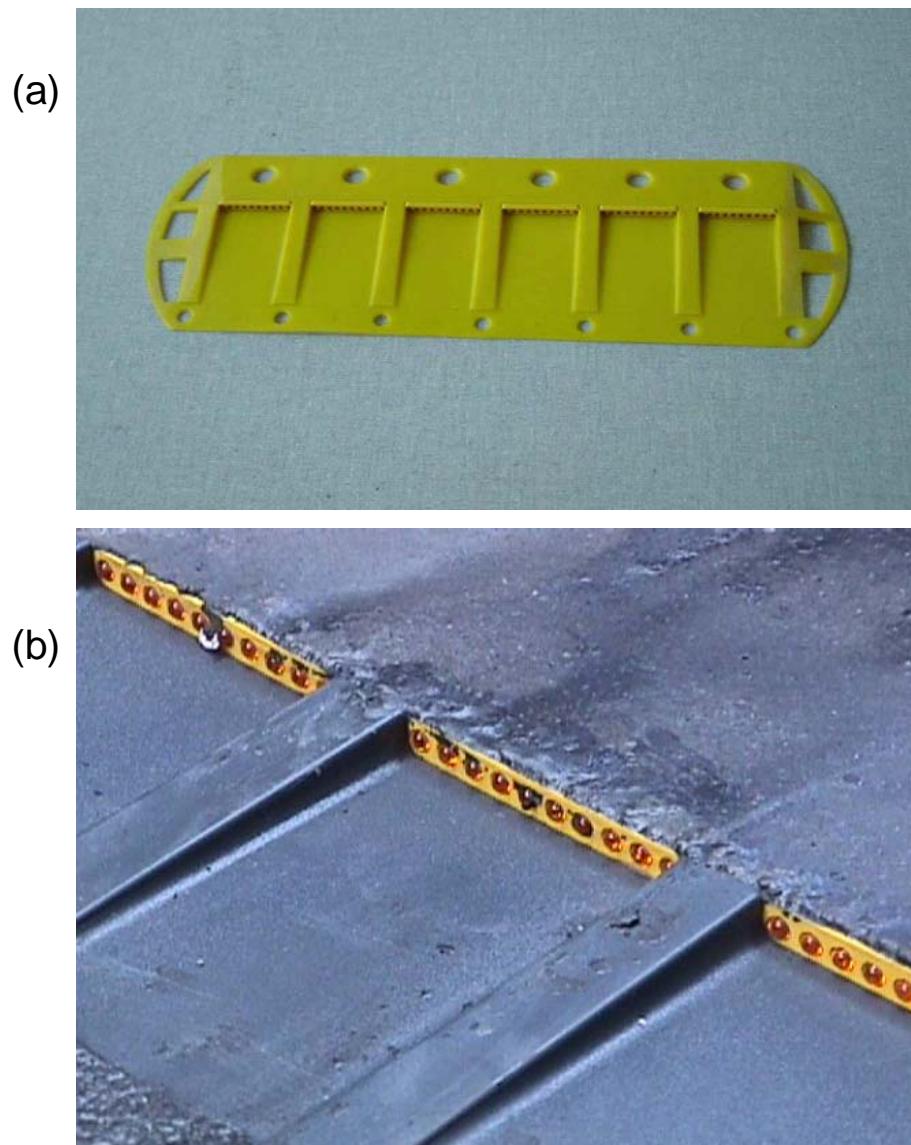
Figure 1 HMB-reflector: generally view (a); applied on the road surface (b).

The HMB-reflector (Fig. 1) has dimensions of 450x150x9 mm and is made of the plastic ABS E200. Its cross-ribs have a length of 75 mm (horizontal projection) and a width of 14 mm. The overall internal distance between the ribs is 47 mm.

From the thermal image it is found that the surface temperature of the zones with no defect ranges between 27.0 °C and 27.7 °C. The HMB-reflectors are easily recognized by their shape (see Fig. 1 and Fig. 8). In addition, six regions of interest (ROI) B1 to B6 appear which were supposed to be delamination zones. This was verified by a longitudinal cut between approximately 250 and 280 mm from the upper edge of the investigated specimen. The longitudinal cut crosses the ROIs B1 to B4 and cores of the ROIs B5 and B6 were also taken.

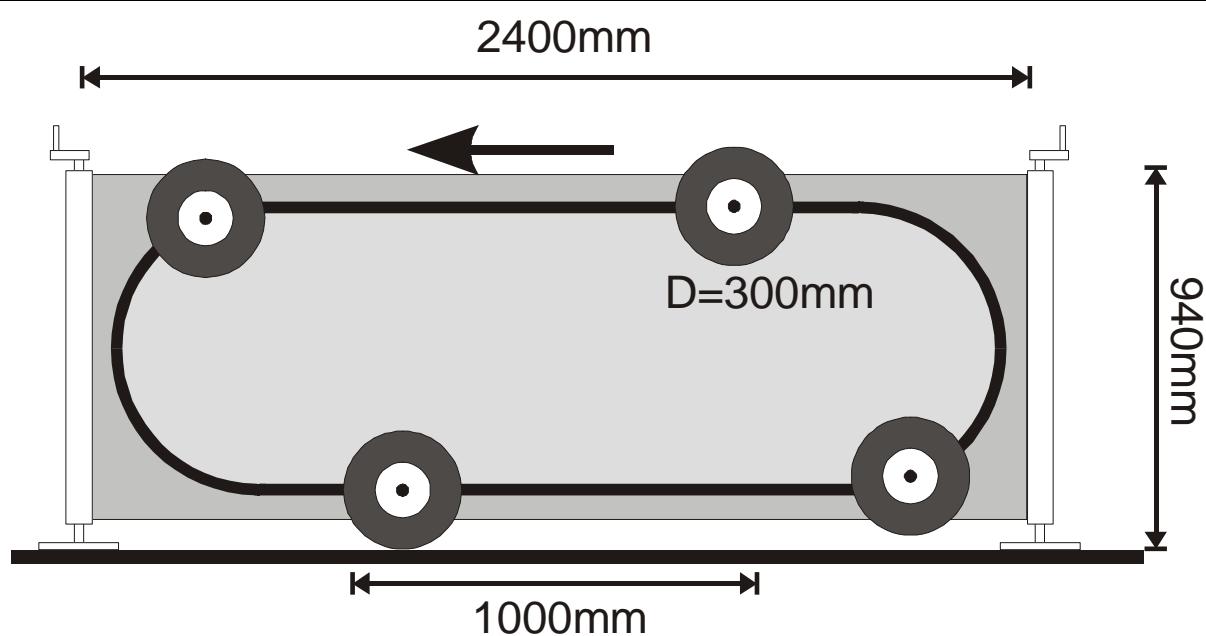
Figure 2 Diagram of MMLS3.

The purpose of MMLS3 is the accelerated laboratory and field testing of the mechanical behavior of pavements under one-way moving dynamic traffic loads, especially the investigation of the surface courses with regard to the permanent deformation (rutting). In this case MMLS3 was also used for testing the resistance to dynamic traffic loads during the wheel passing over the reflectors, in particular the resistance to the corresponding horizontal shear loads. These dynamic traffic loads are generally assumed to produce stress-strain situations within the linear viscoelastic range [1].

The functioning of MMLS3 has been reported in detail elsewhere ([2], [3]). Fig. 2 shows the principle of the MMLS3. Table 1 reports the parameters which were chosen in these reflector tests.

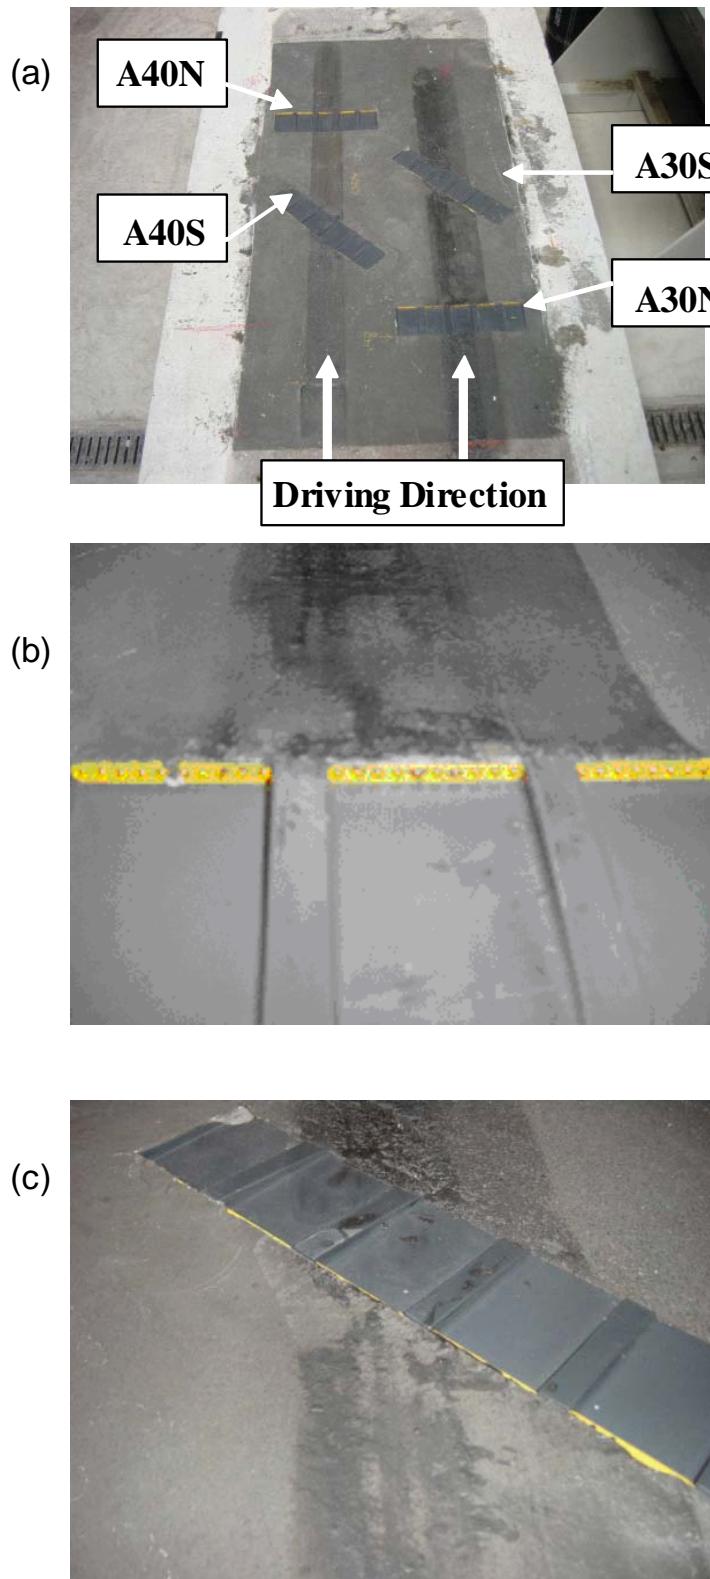
Figure 3 Arrangement of the HMB-reflectors (series A): general view of the testing slab and reflectors labels (a); reflector A30N (b); reflector A30S (c).

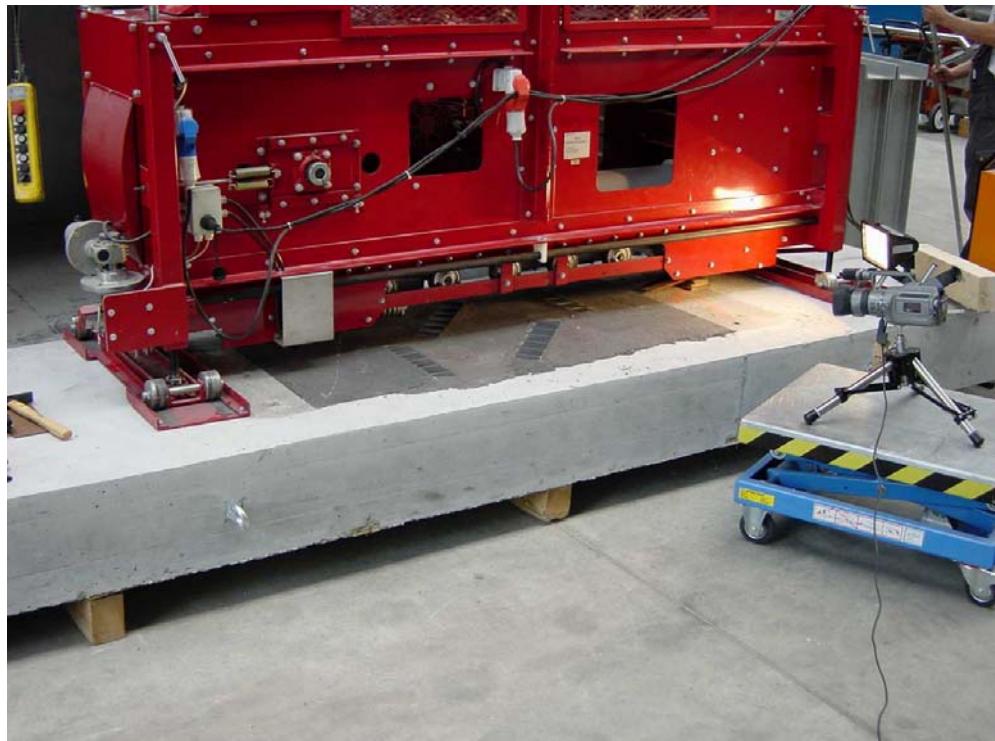
Figure 4 MMLS3, placed on the specimen (series A).

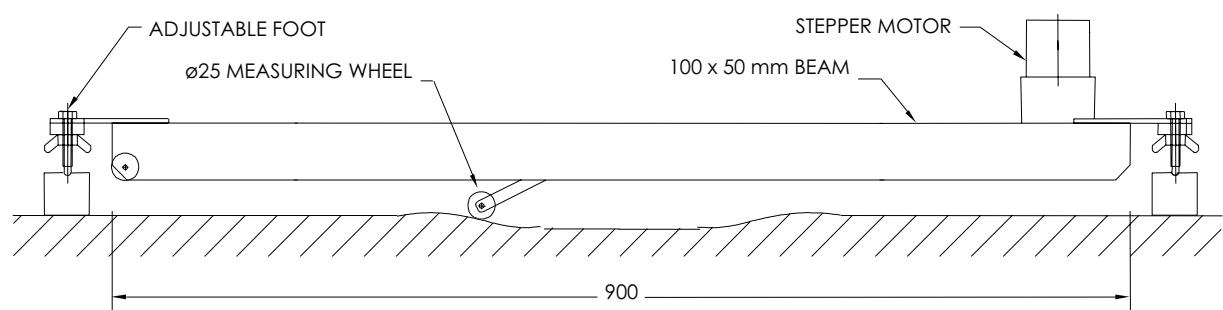
Figure 5 MMLS3 profilometer.

A special profilometer (produced by MLS Test Systems cc) was used in order to measure the rut depths. It was installed under the MMLS3 perpendicular to the driving direction (Fig. 5). For reproducibility reasons the profilometer was mounted on “reference points”. The measurement and recording of testing data was done automatically.

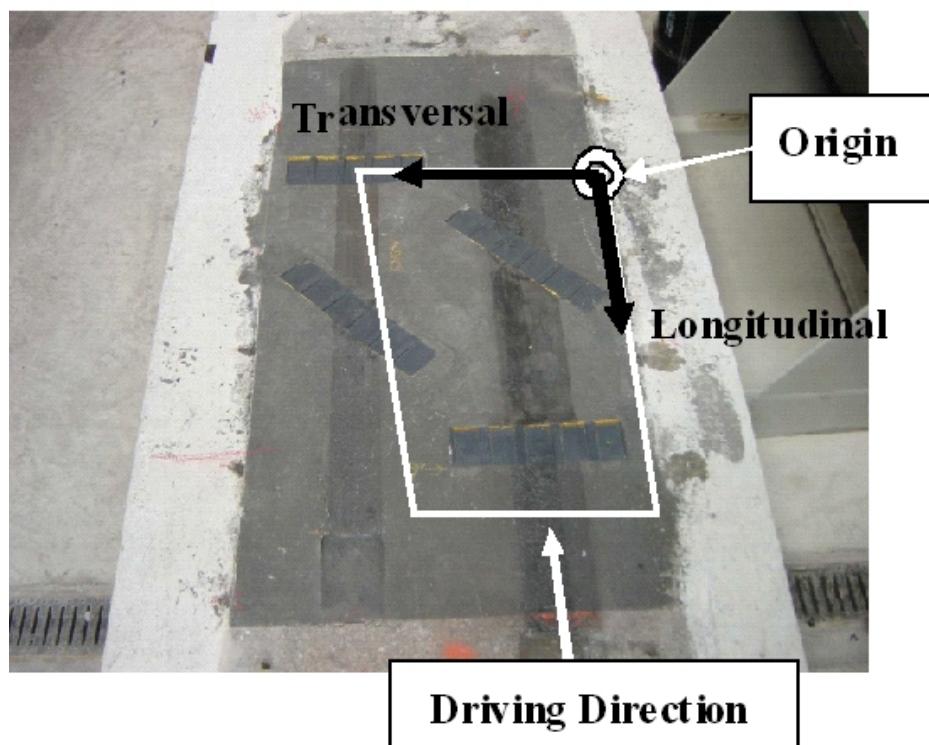
Figure 6 Measuring area (test A30).

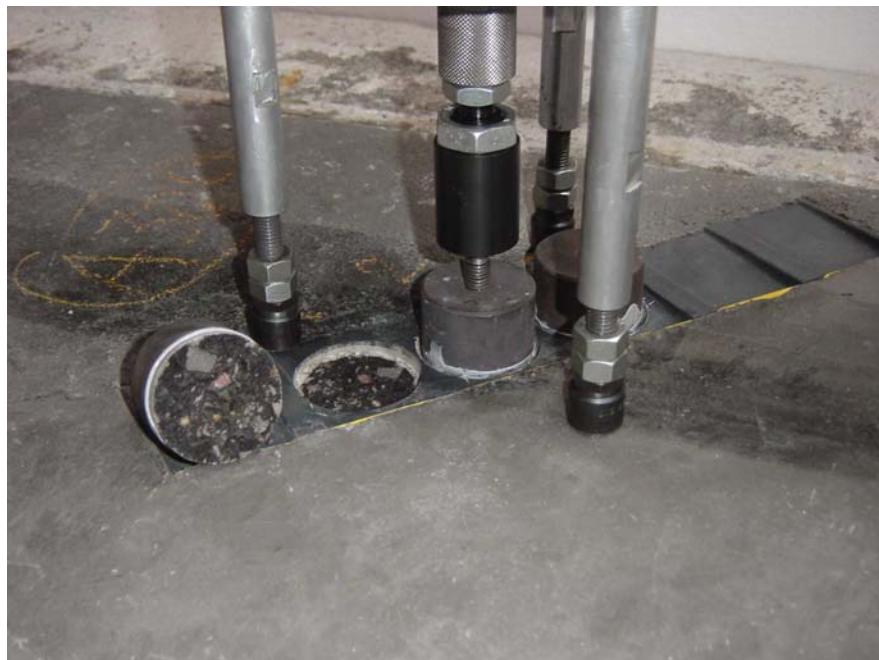
Figure 7 Pull-off test equipment, working zone.

For the preparation of the pull-off tests the chosen testing location had to be leveled out mechanically. For this reason the middle ribs of the HMB-reflectors were removed with a heated putty-knife. After that the circular cuts were made with a 50 mm core. Depending on the testing location the circular cut reached the pavement surface. A 50 mm circular steel plate was glued on the testing location with a 2-component glue. After curing of the glue the steel plate was connected to the servo hydraulic testing machine and vertically pulled with a load controlled velocity of 200 N/s (Fig. 7). All pull-off tests were carried out at room temperature of about T=23°C up to fracture, and the maximum tensile force was measured and recorded.

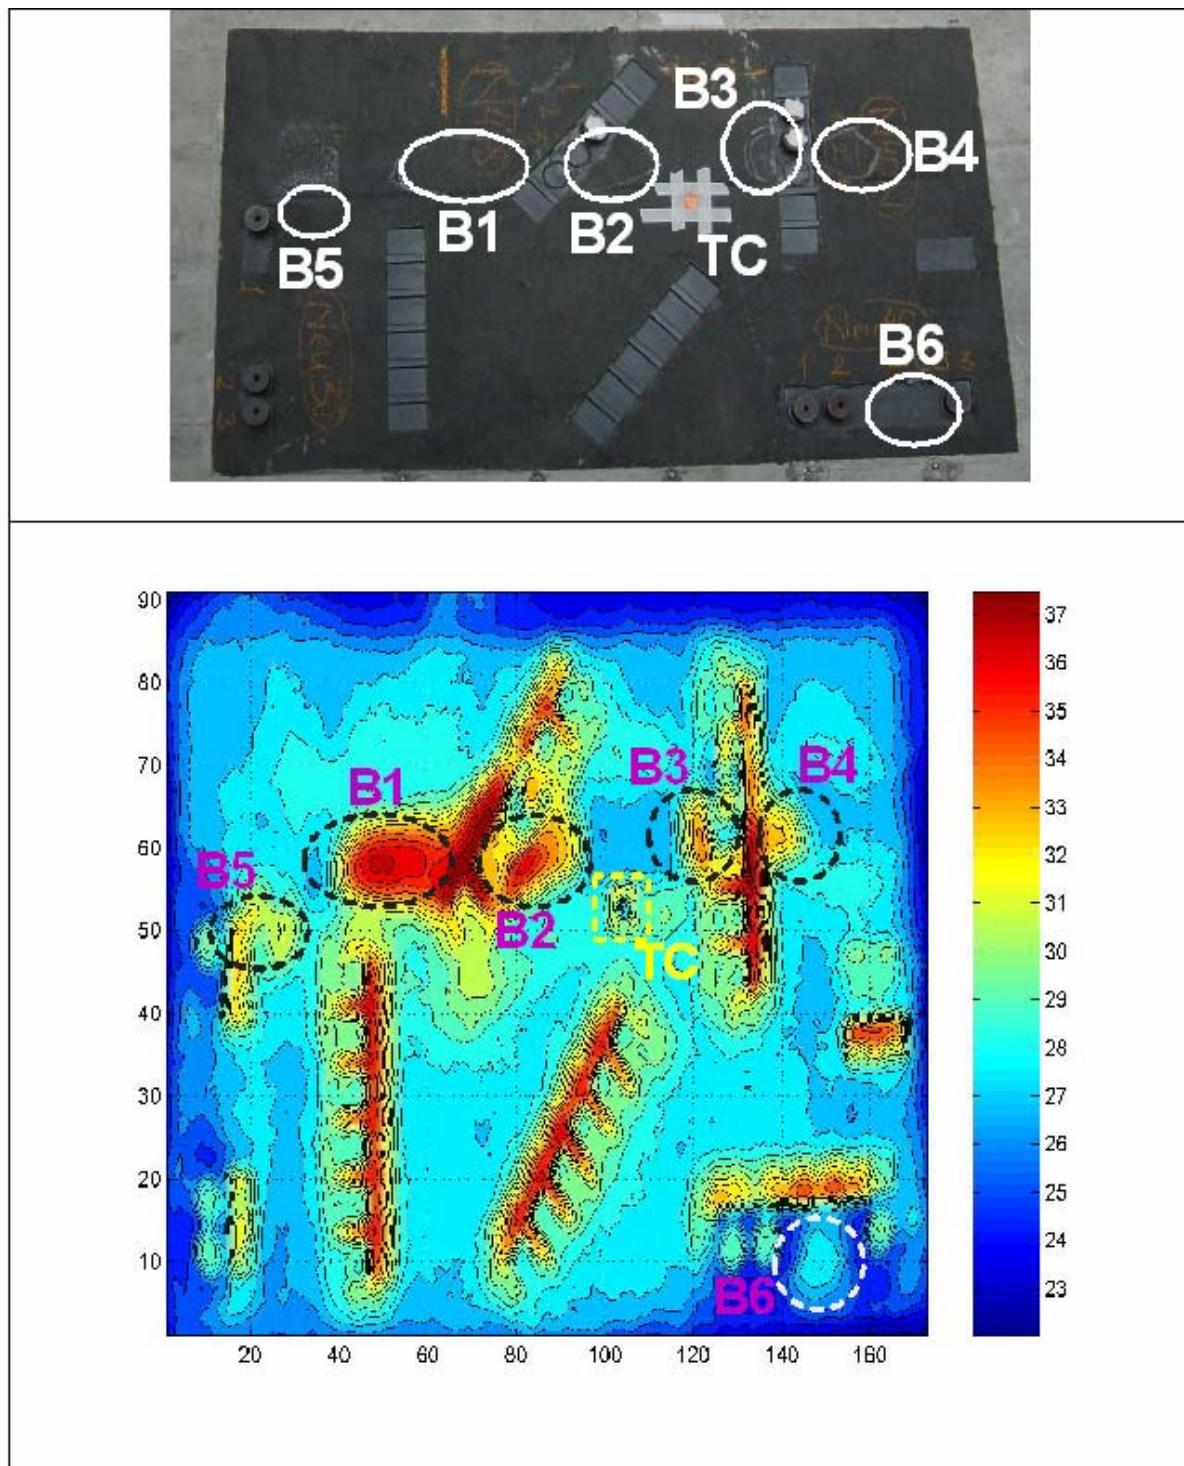
Figure 8 Visual and thermal images of the specimen (cover and HMB-reflectors).

A system of thermocouple and slab of copper was placed in the middle of the upper surface of the sample (see TC in Fig. 8) for monitoring the temperature between the heat transfer medium and the upper surface of the specimen.

Fig. 8 shows the thermogram and the visual image of the specimen. The investigated surface has dimensions of 800 x 1500 mm. The thermogram was taken shortly after removal of the heat transfer medium from the heated specimen surface. For better visualization, the values of the surface temperature were visualized and analyzed with a Matlab application.

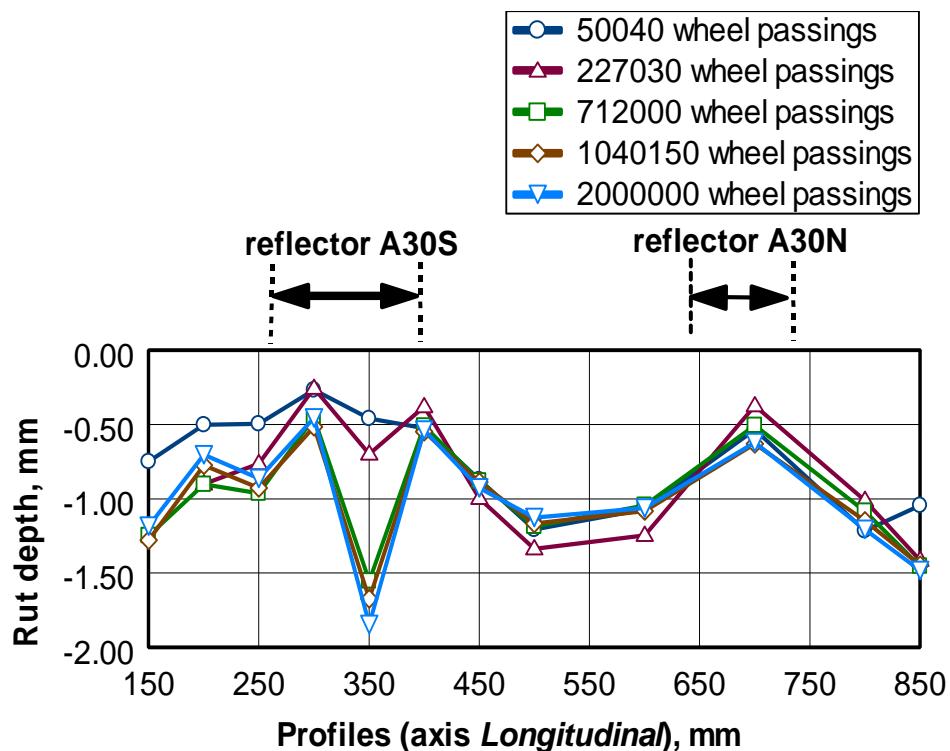
Figure 9 Rut depths, experiment A30: longitudinal profile in the middle of the rut.

Figs. 9 and 10 show the development of the maximum rut depths in Series A with growing number of wheel passings. The rut depths were recorded in the longitudinal profiles in the middle of the rut at a distance of 50mm. Table 2 contains the values of the maximum rut depths for all performed MMLS3-tests.

It can be clearly seen that for both tests of Series A after approx. 0.5 millions wheel passings there is practically no increase in rut depth. In addition, the development of rutting at 40°C is considerably faster than at 30°C, producing results which are apparently less influenced by local disturbances like in case of the abnormal increase of deformation under the diagonally applied reflector A30S. This was one of the reasons why Series B was only tested at 40°C. For Series A the visual observation of the tested HMB-reflectors and the 2-component HMB-cover material in the ruts and in the border areas showed no local damages. Furthermore no loss of adhesion between the HMB-glue layer and pavements surface was observed.

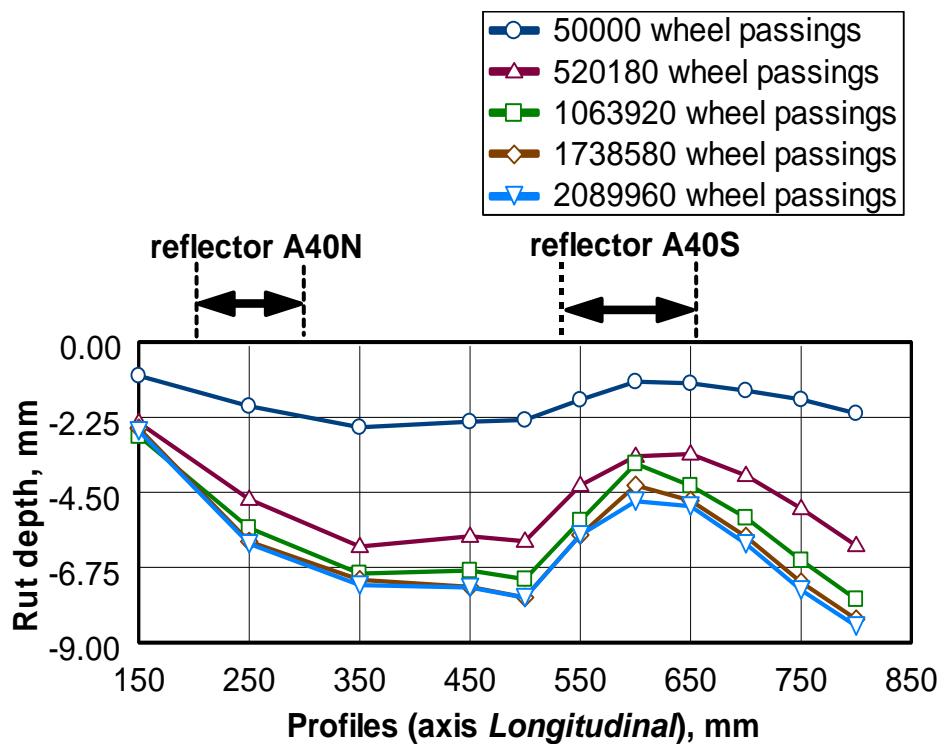
Figure 10 Rut depths, experiment A40: longitudinal profile in the middle of the rut.

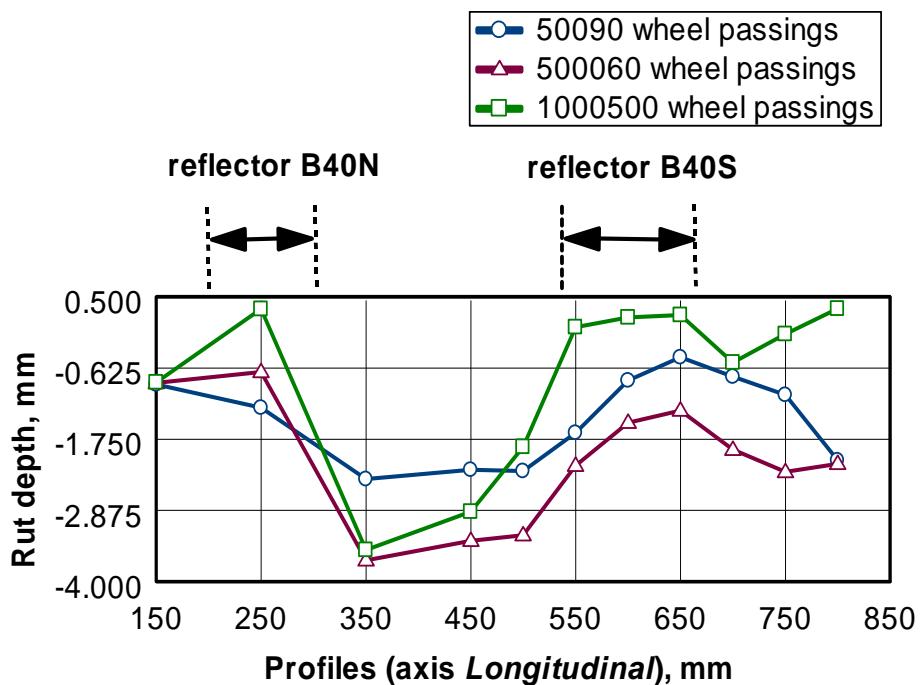
Figure 11 Rut depths, experiment B40: longitudinal profile in the middle of the rut.

Fig. 11 shows the development of the maximum rut depths for Series B at 40°C. Rut depths measured in this series after 50'000 wheel passings show similar values as in test A40 (Fig. 10). However, the rut depth after approx. 500'000 wheel passings is considerably smaller. After 1'000'500 wheel passings the measured values of the rut depths are even smaller than after 50'000 passings at the beginning of the test. The reason for this is the elastic recovery of the surface after debonding of the HMB-reflectors and HMB-cover material from the pavement surface (Fig. 12).

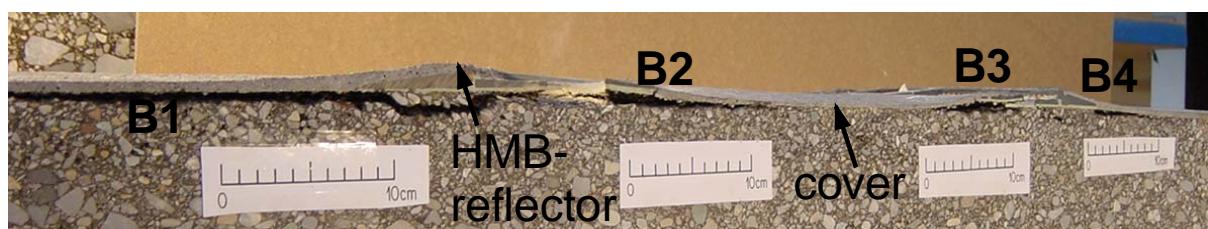
Figure 12 Vertical section of the longitudinal cut (B1U, B2U, B3U, B4U).

It is concluded that B1 to B4 are delaminations (see Fig. 12), while B5 and B6 are caused by the thickness discontinuity of the cover and of the HMB-reflector shape.
